Oxford Preservation Trust

26/26a East St Helens, Abingdon

An Investigation of a Medieval Town House

Oxford Archaeological Unit
February 1995

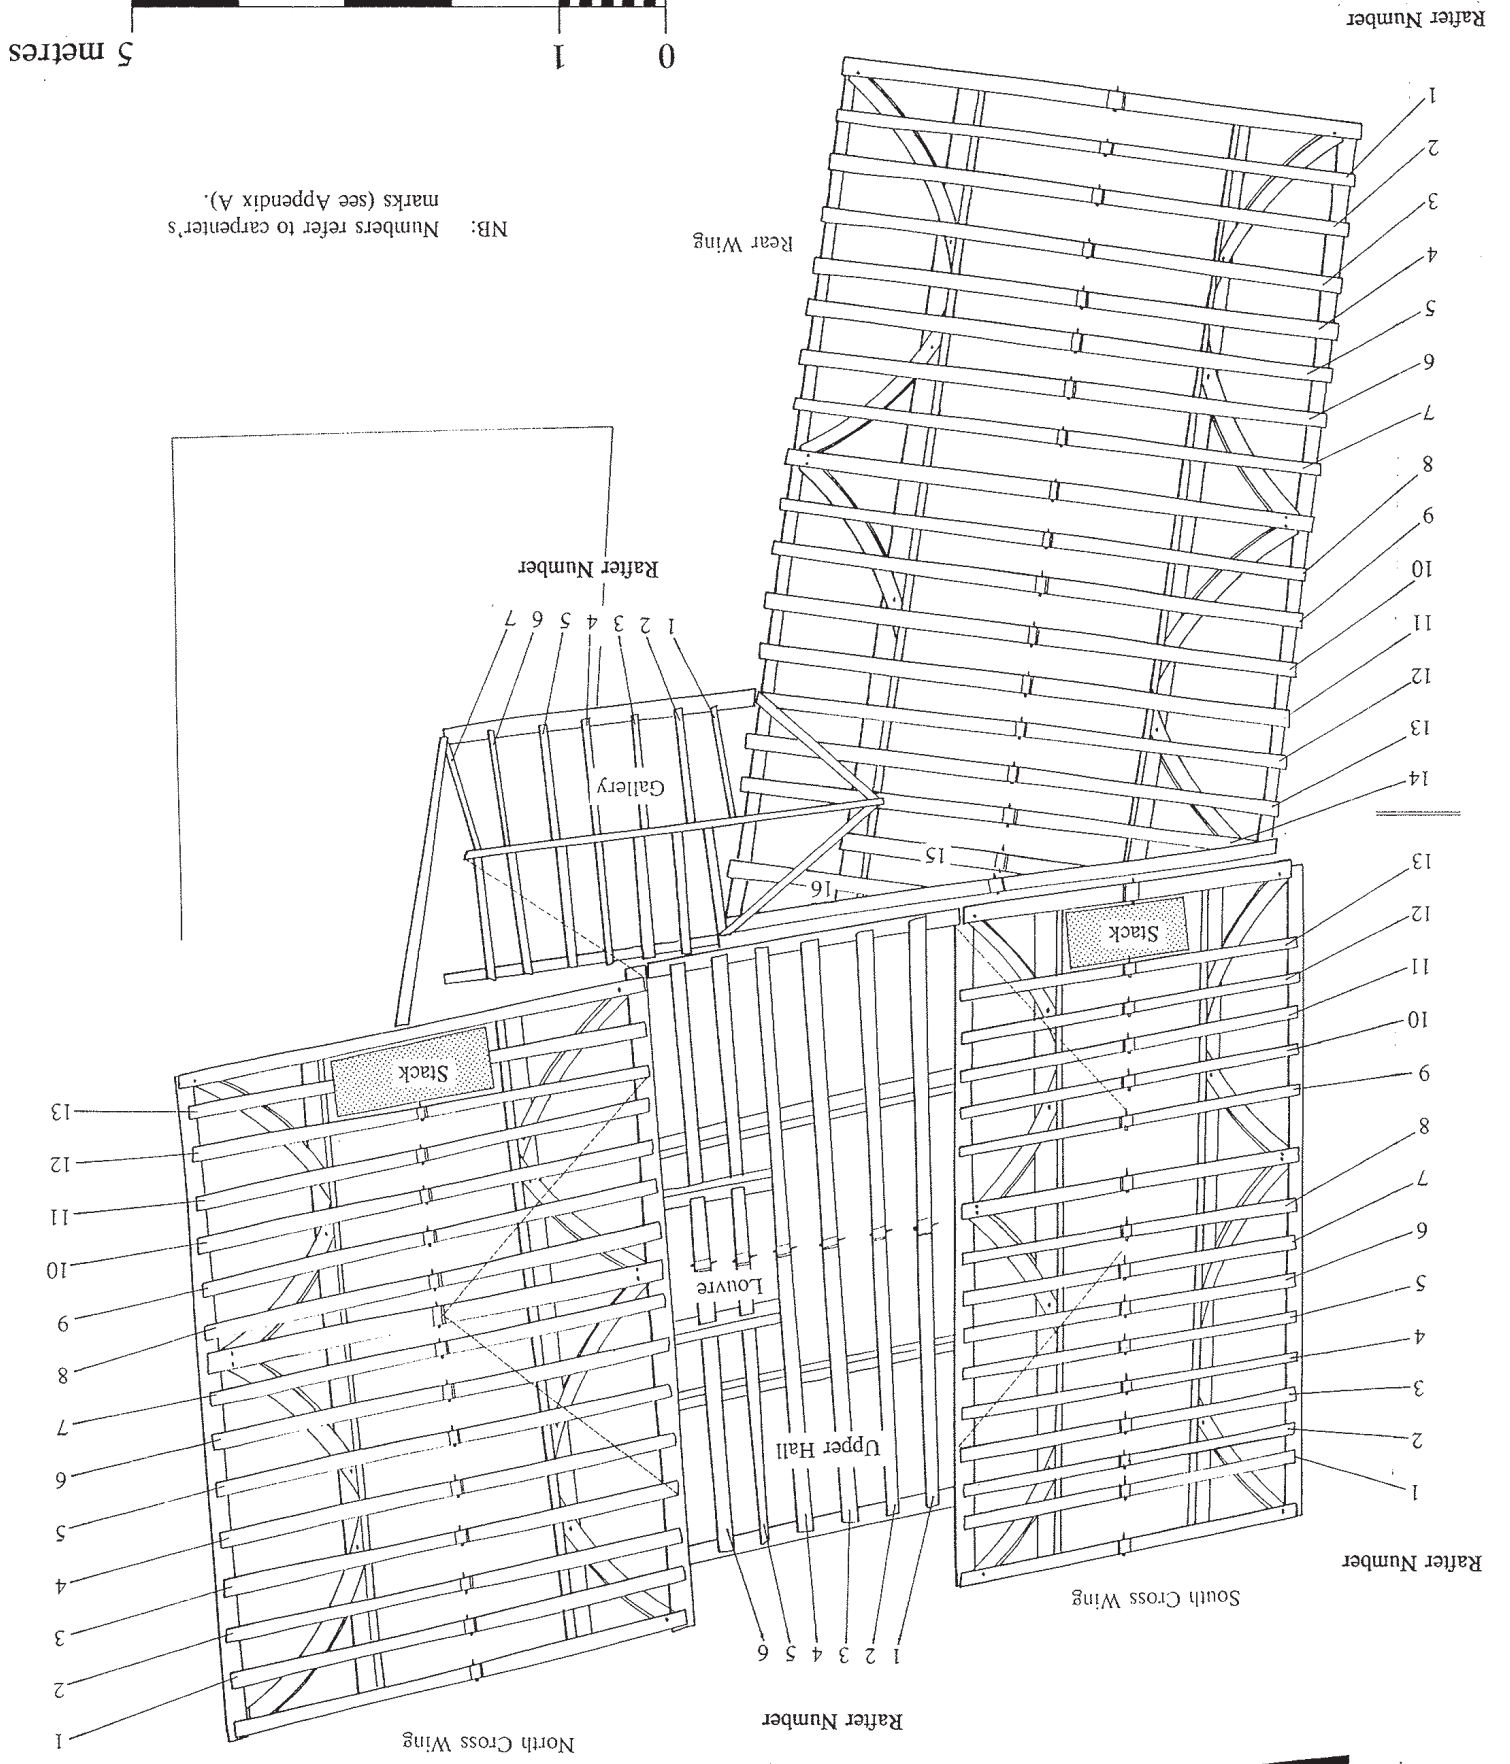
Plan of Roof Timbers

- 4.4.3 The carpenters' marks for reassembling the prefabricated frame are of standard late-medieval type, Roman numbers scribed with long strokes up to 15 cm long. They are of similar type on front and back parts, though while the front was assembled according to the numeration the roof of the back was disordered (see Appendix A).

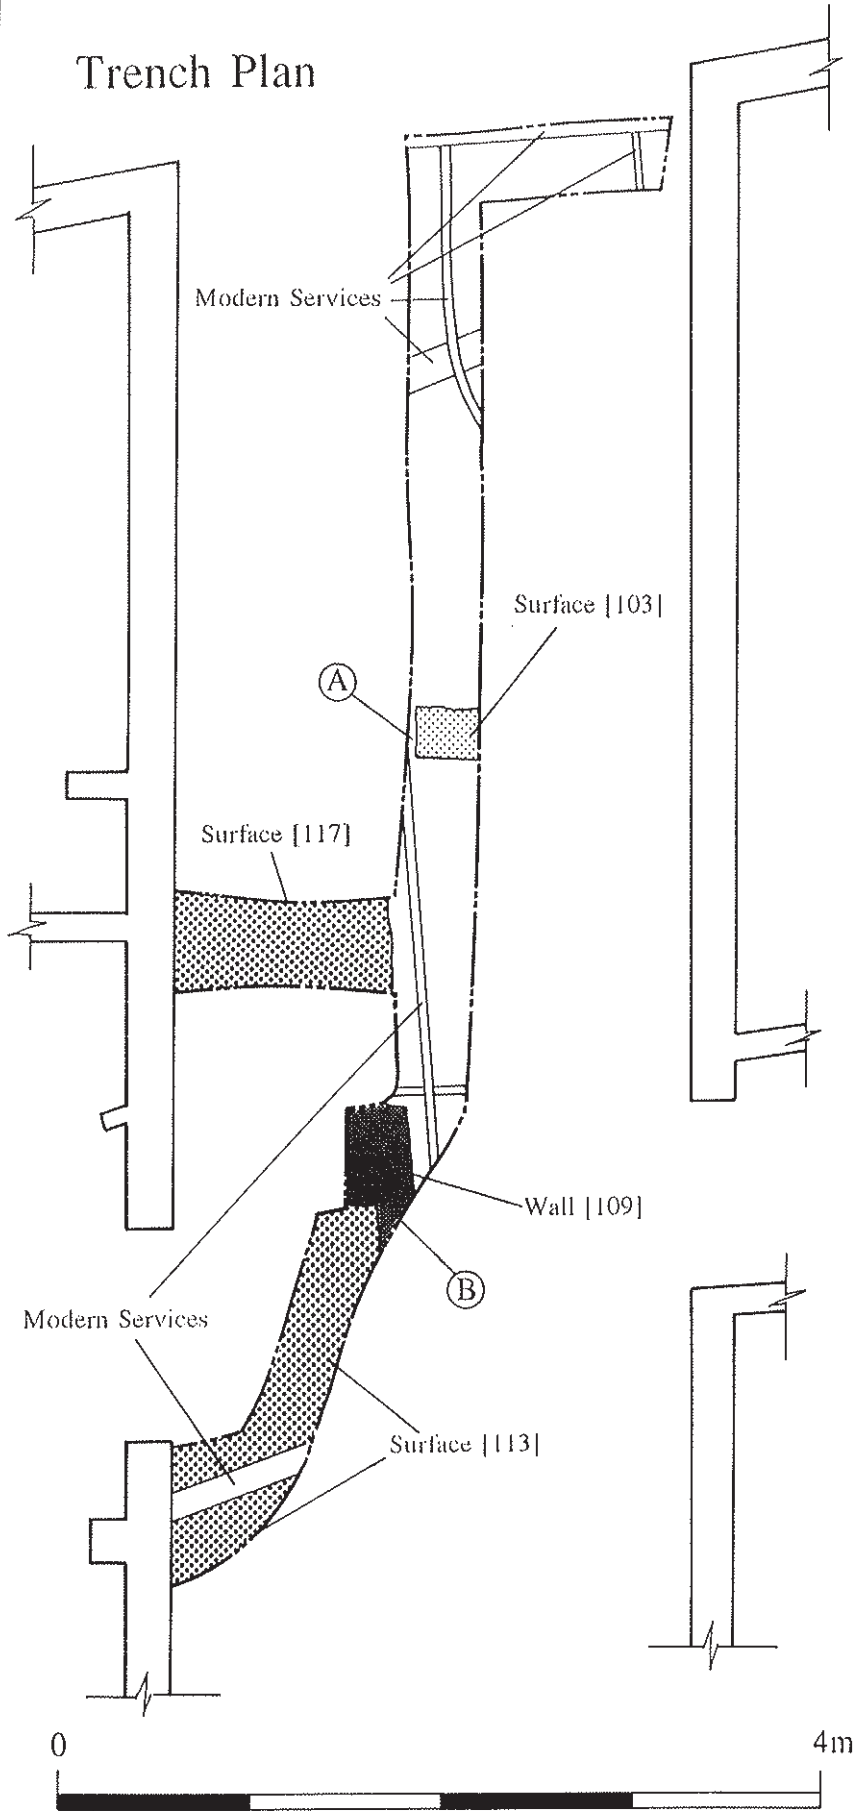
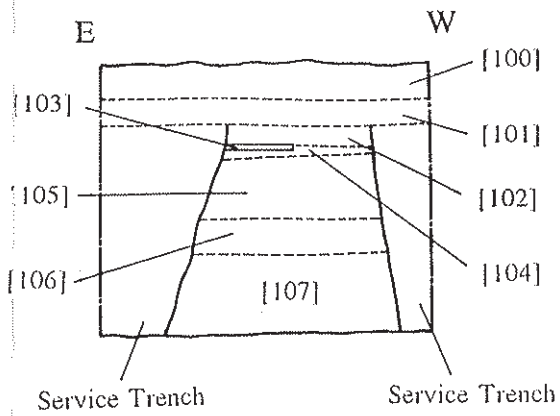
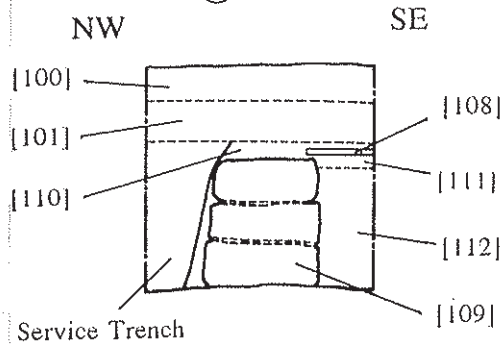
Figure 7: Plan and Sections of Carriageway Excavation

- 6.4 Beneath [108] and [111], the remains of a fairly substantial wall footings [109] of roughly hewn chalk blocks were exposed surviving to three courses (see fig.7). At the point of exposure, [109] could be seen to be forming a junction which would appear to correspond with the east (rear) wall of 26a front range and the north wall of the rear range (as represented by the line of sawn-off posts at first floor level, see fig. 3). Excavation to the east of [109] revealed a worn stone surface [113] at a depth of 0.60m below modern ground level. It was noted that [113] was present throughout the remaining eastern extent of the excavated trench.

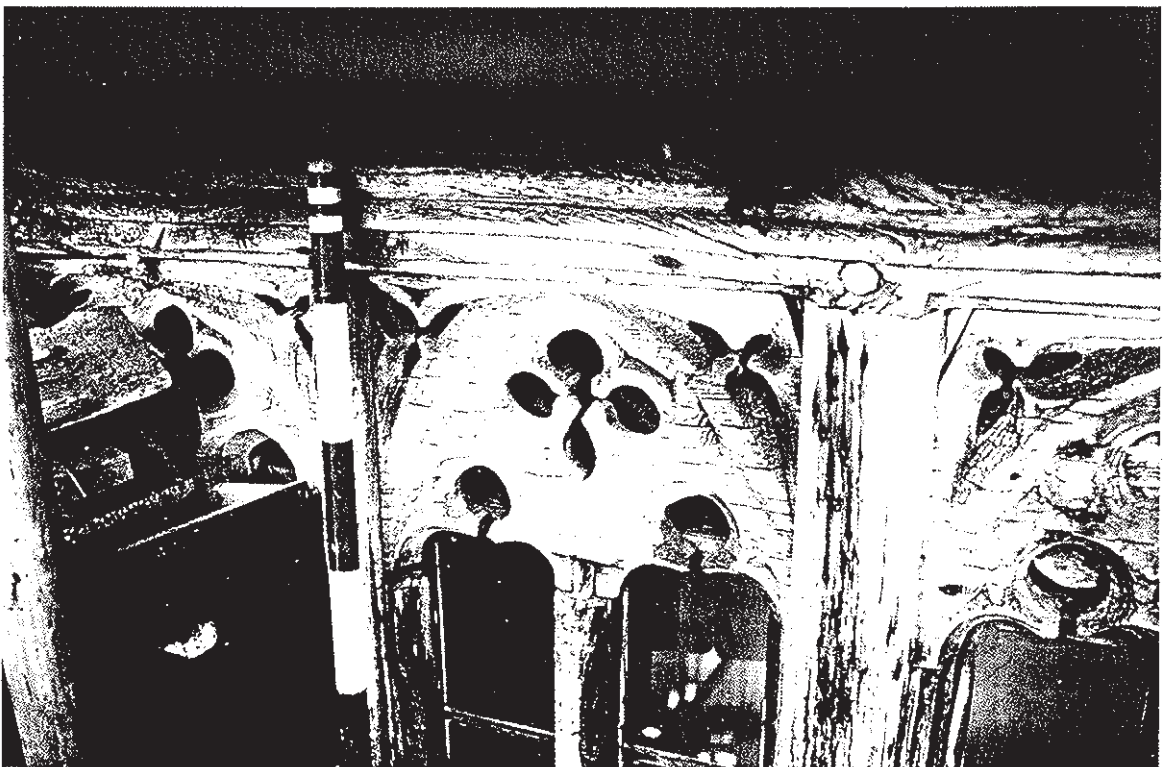
Plate 2: Detail of gallery window.

ceiling identical to that in the south wing. The gallery itself is glazed on the east side with one continuous window of many arched and traceried heads (see Plate 2). The north wing has been rebuilt, and little can be determined of its original form.

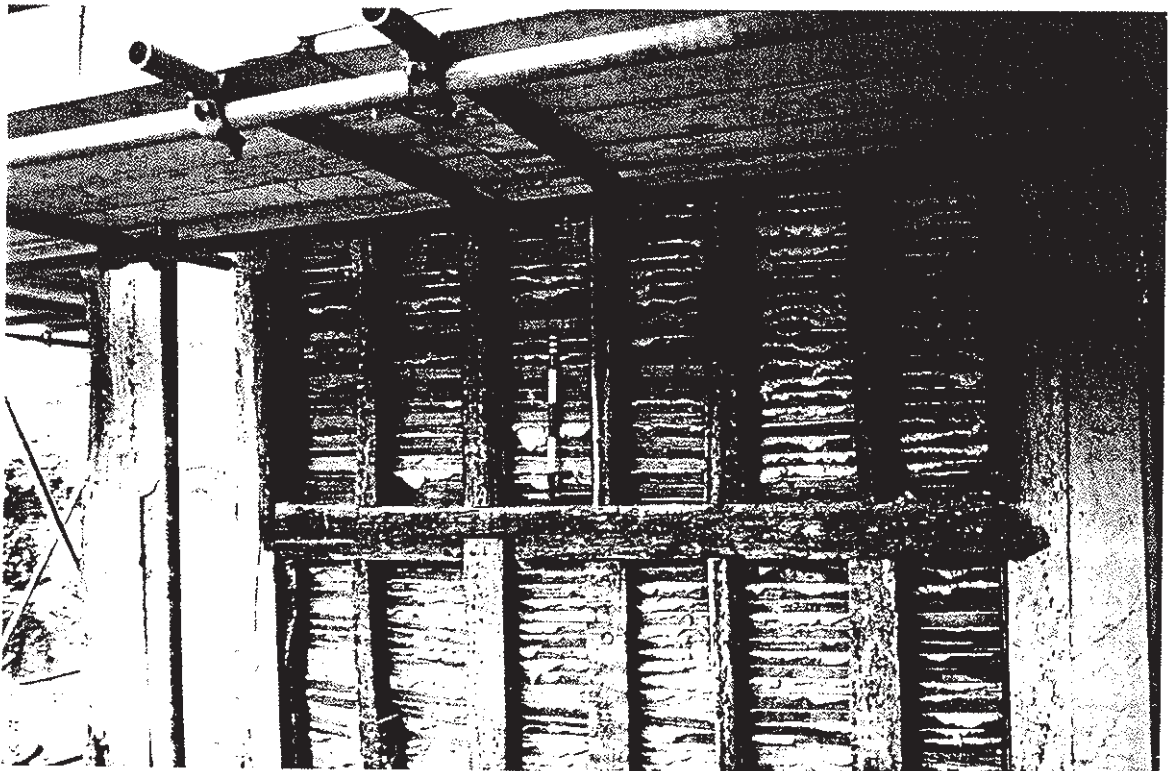
Plate 6: Exposed window framing: rear south wing.

- 4.2.2 When the render was removed from the side wall of the south rear wing some areas of original lath and plaster were found near the main house (pl.7), but towards the east end of the wing a *blocked window* was uncovered (pl.6). This had been a six-light window with ovolo moulded mullions, which had all been turned when the wall was plastered and were not in their original positions, but it appears there were two large and three small mullions. This was evidently not the original window here, since the framing that contains the window is not pegged into the framing of the house, and mortices could be seen from an earlier and no doubt original window. This was set between two posts of which only the peg-holes and mortices survive and was possibly a bay window, since in the wallplate above the window are three mortices for horizontal members coming out of the wall. This could support a small bay similar to the mid-sixteenth century ones at the Golden Cross Inn, Oxford. There the bays have canted sides, though here the mortices are straight edged and not chased as might be expected if the sides were angled. It is uncertain whether the modern window in the bathroom is on the site of an original one; it has old plaster below and around it.

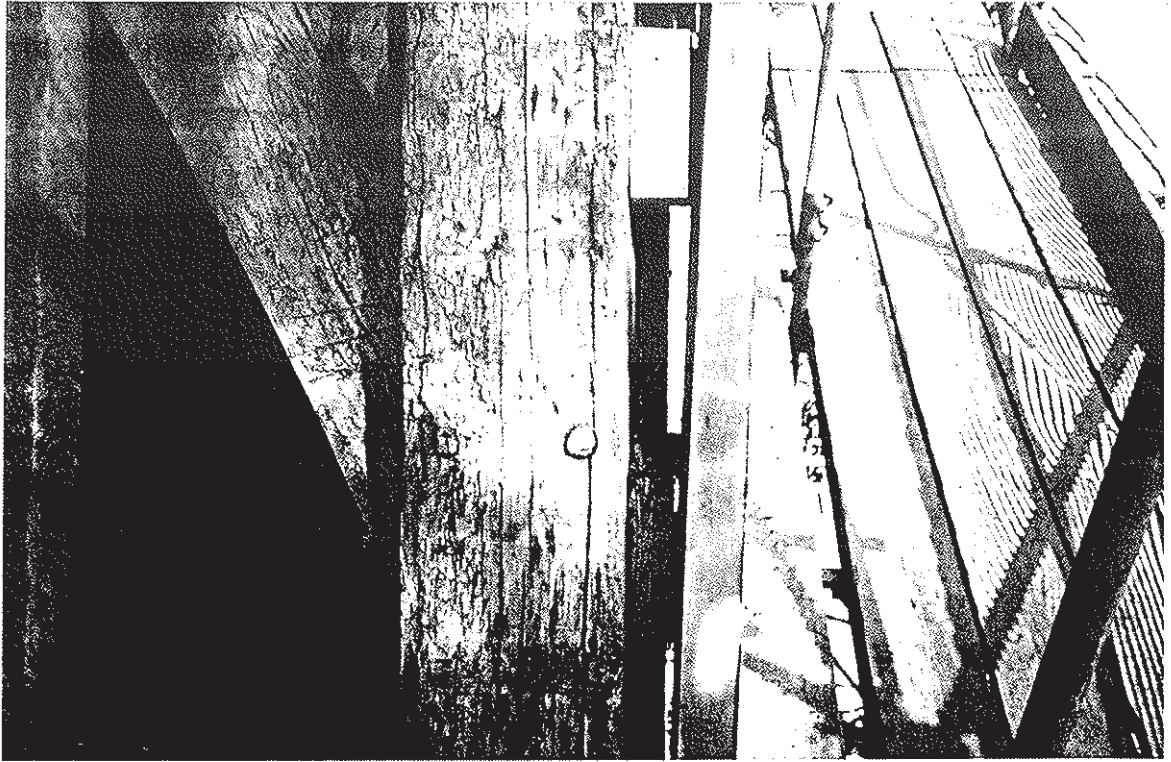
Plate 9: Evidence for continuation of rear south wing.

- 4.2.3 The back wing appears to have had an *eastward continuation* when first built. The evidence for this is to be seen in the principal rafters in the back wall, which have mortices for windbraces both on the inside (for the existing windbraces) and also on the outside, as if the roof had carried on (pl.9). Neither the tiebeam nor the first-floor principal joist have mortices for any continuation of flooring (pl.10), but the corner post does have a mortice for bracing on the outside, as if the wall had been continuous. Since the first floor is tenoned into the rear principal joist and the joist has no mortices on the outside, one possible explanation is that there was another open hall here, built against the stone wall which continues down the side of the garden.
