Oxford Preservation Trust

26/26a East St Helens, Abingdon

An Investigation of a Medieval Town House

Oxford Archaeological Unit
February 1995

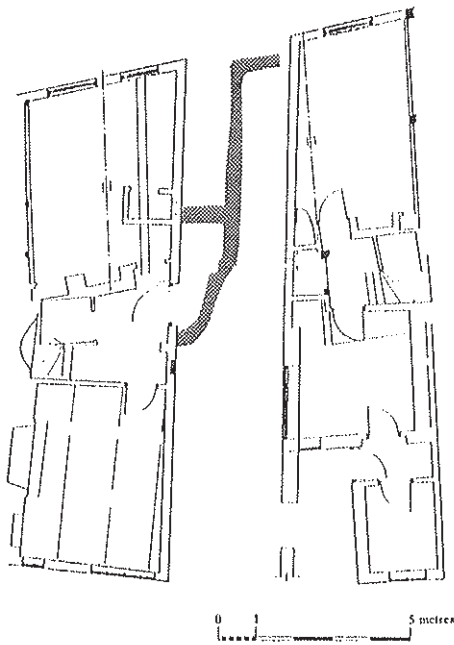
Figure 7: Plan and Sections of Carriageway Excavation

ground level. Tile dimensions were 0.14m x 0.14m x 0.03m and were bedded in 0.04m of clean fine sand [104]. Layer [103] was overlaid by a thin (0.08m) layer of probable demolition debris/make-up material [102]. Only a small area of [103] survived due to its disturbance to both east and west by modern services (fig.7). Further east (in the area of the present doorways to north and south) another small discrete area of tile surface [108] survived at a depth of 0.22 below modern ground level. Only three tiles were partly exposed within the trench, these were black with white spiral decoration and were bedded in a thin layer of light grey gravelly mortar [111]. The orientation of the intact edges of tiles [108] did not correlate with the alignment of the extant building walls or with the tiled surface [103]. Again the isolated and partial survival (disturbed by modern services) of [108] make interpretation problematical.

- 6.4 Beneath [108] and [111], the remains of a fairly substantial wall footings [109] of roughly hewn chalk blocks were exposed surviving to three courses (see fig.7). At the point of exposure, [109] could be seen to be forming a junction which would appear to correspond with the east (rear) wall of 26a front range and the north wall of the rear range (as represented by the line of sawn-off posts at first floor level, see fig. 3). Excavation to the east of [109] revealed a worn stone surface [113] at a depth of 0.60m below modern ground level. It was noted that [113] was present throughout the remaining eastern extent of the excavated trench.
